Safety notice: small toggles may break, posing fall hazard

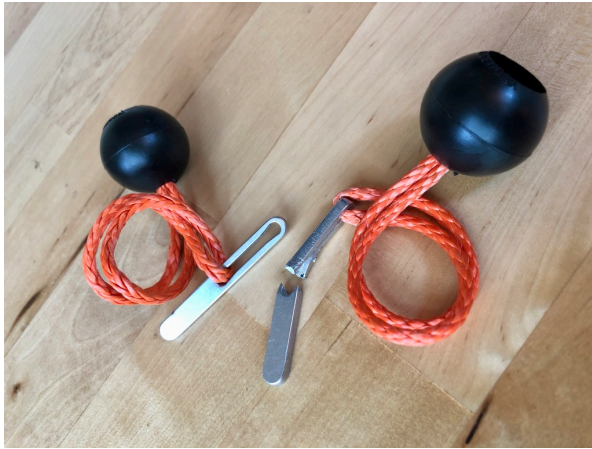
Most Tensa4 stands sold between December 2018 and April 2019 feature small toggle and loop assemblies to connect the poles. The small toggles, pictured below, should no longer be used as originally directed, because they may break.

The issue is that these small pins are too easily damaged, sometimes invisibly, in rough handling, accidents, or extremes of normal use, and they may then break under load. We have received enough reports of this happening (about 0.25%) to expect more cases without preventive action.

We will replace any broken small pin assemblies while stocks remain, noting that you should use only as a push pin to thread the lines through the holes in the ends of the poles, not to secure the connections as a toggle. Use carabiners for that.

Affected users may opt to migrate to the new larger toggle specification for the cost of shipping. We require return of the 8 end segments of each stand (minus feet) to perform the necessary modifications.

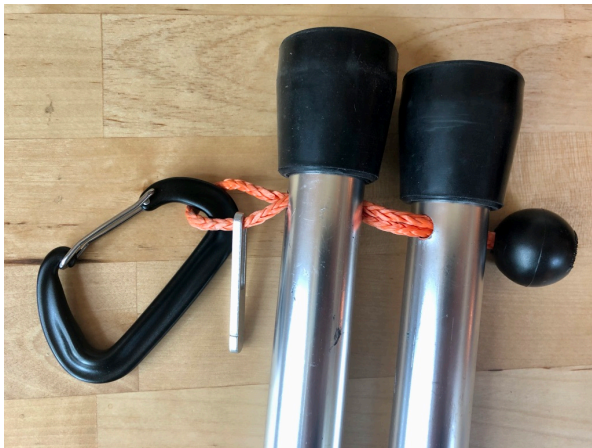
Instead, users should secure the connections using a carabiner on the outside of the loop, like this:
